## **Pre-Purchase Inspection – Residential Building Report**

Inspected property address:	<b>2 Leask Avenue MILDURA VIC 3500</b>	
Inspection date:	<b>2 August 2021</b>	Time: <b>9:00am</b>
Weather conditions:	At time of inspection: <b>Dry</b>	Recent: <b>Light rain</b>
Client details:	Name: <b>Angela Kalamaris</b>	
	Address:	
	Phone:	
	E-mail: -	
	Client present at inspection: <b>No</b>	
Building Consultant conducting inspection:	<b>Stephen Burgess</b> <b>Registered Building Practitioner DB-U 14134</b> <b>Phone: 0404 009 611</b>	
Real Estate Agent:	<b>Cheryl Reberger</b> <b>Collie and Tierney Mildura</b> <b>Phone: 0408 214 360</b>	Present at inspection: <b>No</b>
Additional persons in attendance at inspection	-

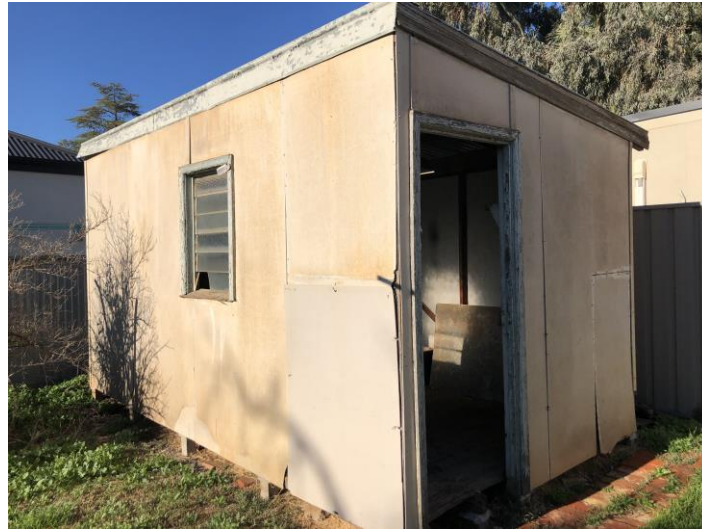
#### Shed

The garden shed structure is unstable and in an overall deteriorated state. There are wood rot damaged timbers throughout and loose and damaged wall cladding sheets. The wall cladding sheets are not painted exposing raw material.

There is a possibility of the wall cladding sheets containing asbestos. This presents a potential safety hazard if interfered with.

Seek special purpose asbestos inspection before conducting any alterations and licenced Builder to rectify.

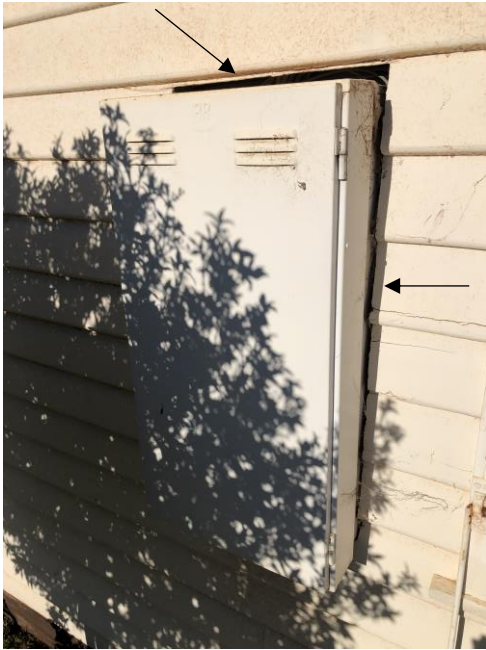
### External Cladding

There are gaps around the power meter box which will allow water to enter inside the wall cavity.

This presents an electrical safety hazard and will allow water to enter unintended locations.

Contact licenced Builder to rectify

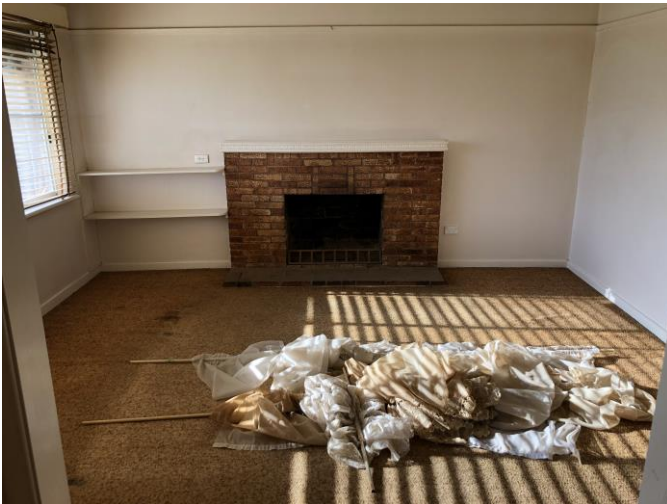
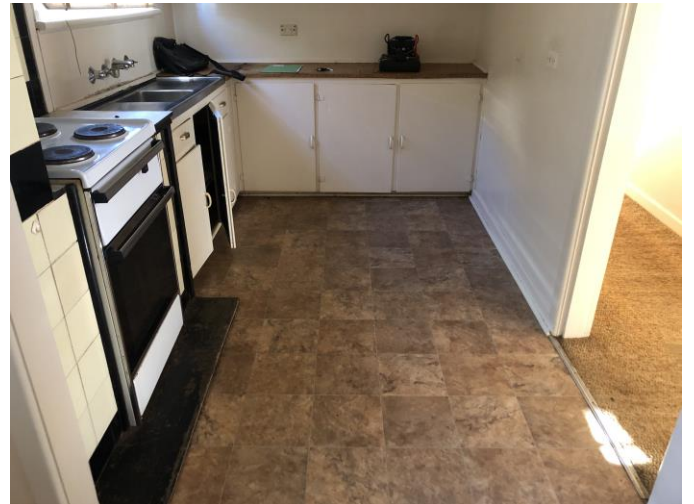
### Floors

The floors throughout the entire house are distorted, out of level.

Contact licenced Re-stumper to rectify.

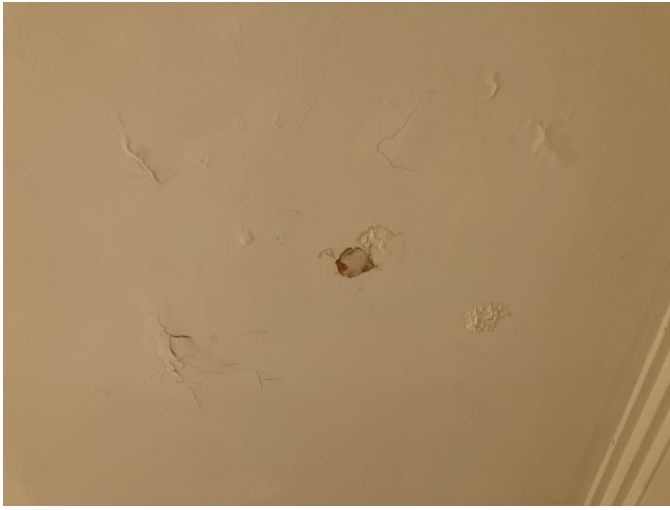
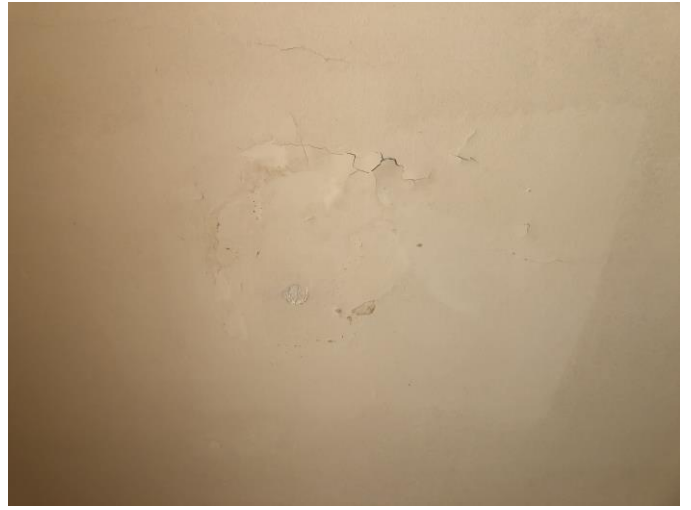
### **Ceilings**

There is some moisture damage present in the loungeroom, passage and middle bedroom plaster ceiling sheets.

This indicates water has been entering unintended locations.

Contact licenced Plumber to investigate water ingress and rectify.

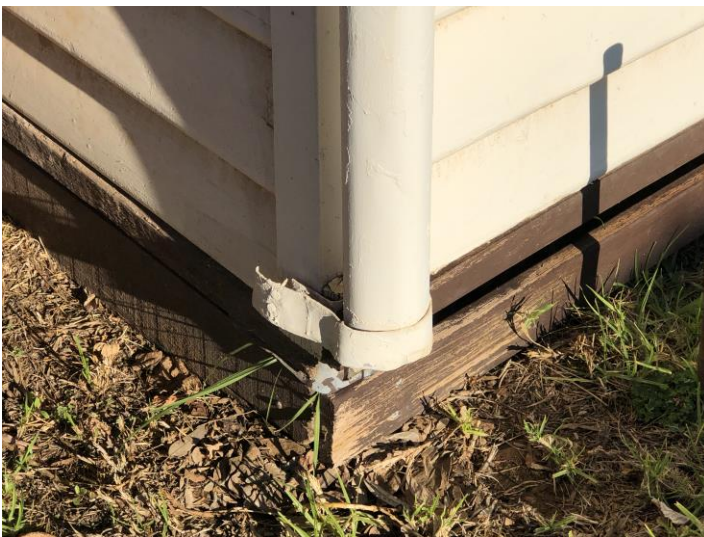
### **Gutters and Downpipes**

The front house downpipes are not connected to a stormwater piping system.

This will allow water to spill into unintended locations and run back under the house which may cause foundation issues.

Contact licenced Plumber to rectify.

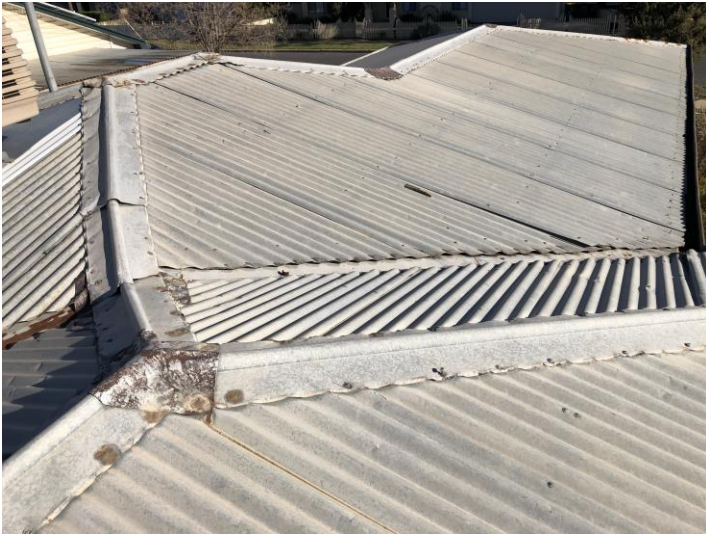
### **Roof Flashings**

The roof flashings require maintenance. There are some squashed roof flashing sheets and some loose and missing fixings over the entire roof area.

This may allow water to enter unintended locations.

Contact licenced Plumber to rectify.

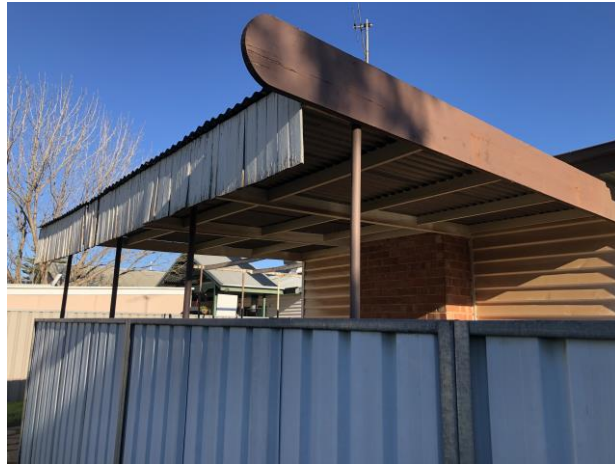
- There was no power connected at time of inspection.
- The carport has no guttering system installed. There is some wood rot damage in the outside roof framing timber components.

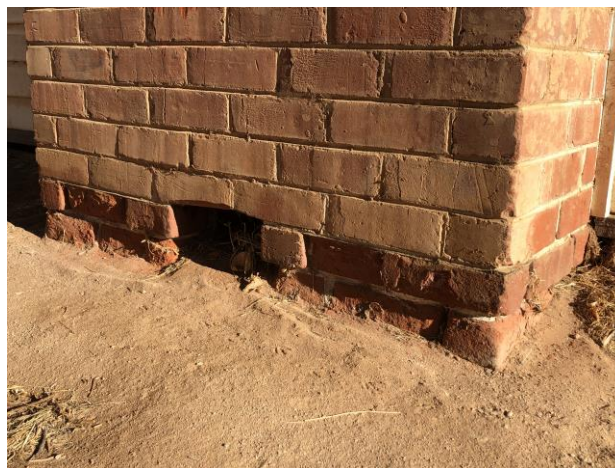
- There is some material deterioration in the form of corrosion in the bottom few courses of bricks in the loungeroom chimney. Monitoring required as further deterioration will weaken the chimney structure. Contact qualified Bricklayer to rectify.

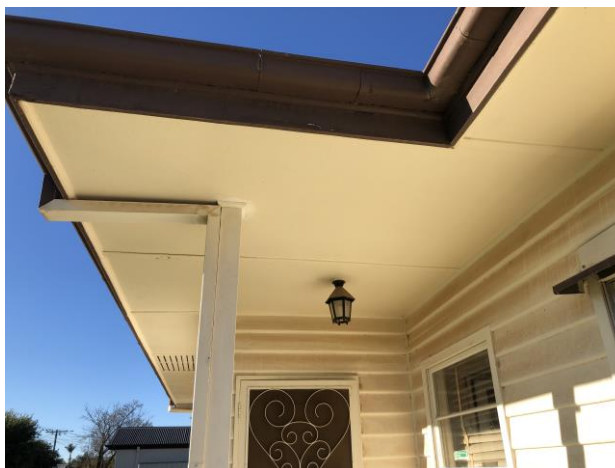
- There is a possibility of the eave linings containing asbestos. This presents a potential safety hazard if interfered with. Seek special purpose asbestos inspection before conducting any alterations.

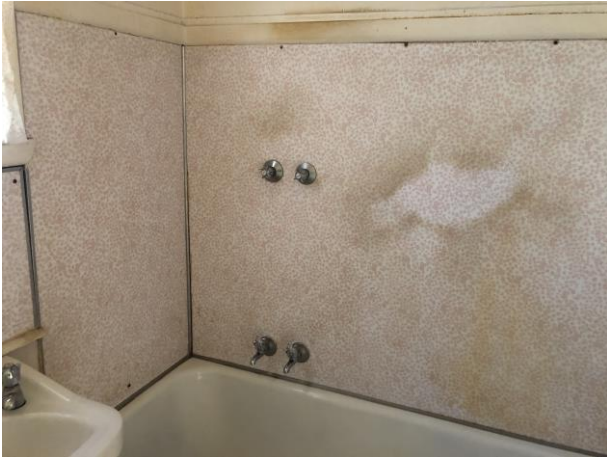
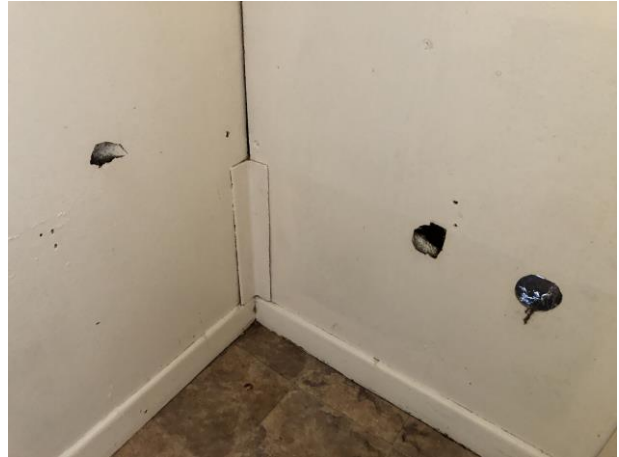
- There is a possibility of the bathroom patten wall lining sheets and the laundry wall and ceiling lining sheets containing asbestos. This presents a potential safety hazard if interfered with. Seek special purpose asbestos inspection before conducting any alterations.

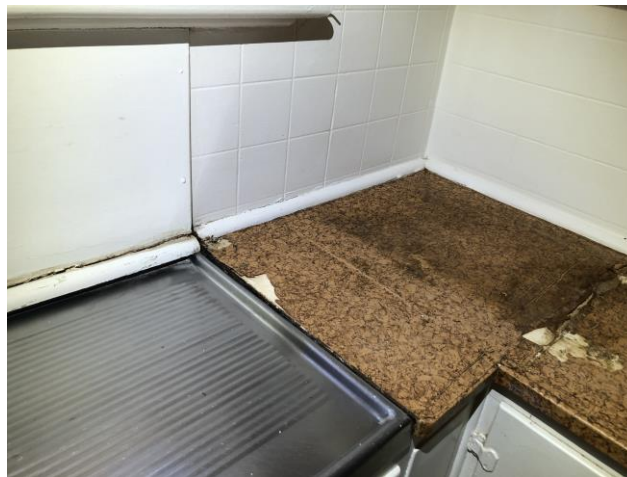
- There is some moisture damage in the kitchen wall splash back sheeting and in the timber bench tops.

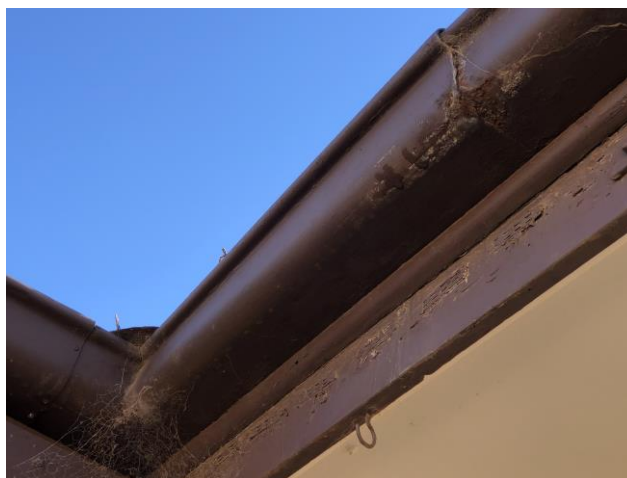
- There is some rust damage in the house gutters. The guttering system is blocked and requires cleaning to allow water to escape as intended.

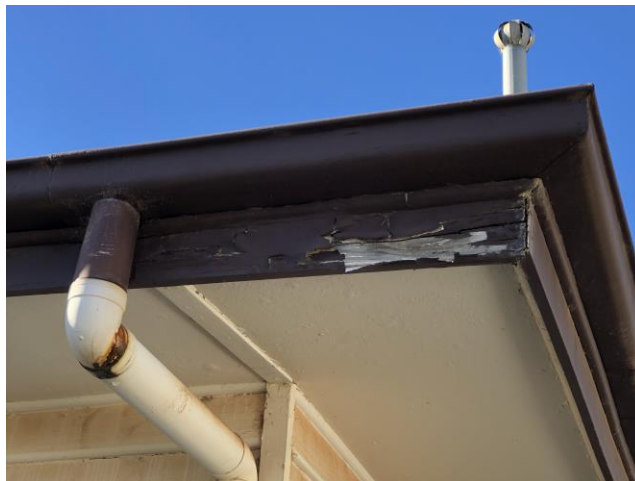
- There is some wood rot damage in the house timber fascia boards.
