Pre Purchase Timber Pest Inspection Report

AS4349.3-2010

Brendon Ede Pest Management

2 Leask St Mildura

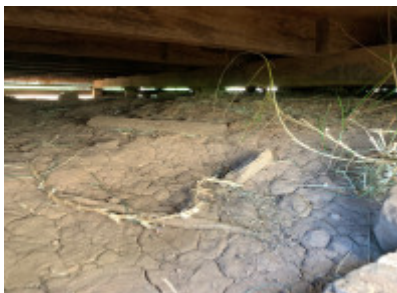
<p>Subfloor Too low for physical access.</p>

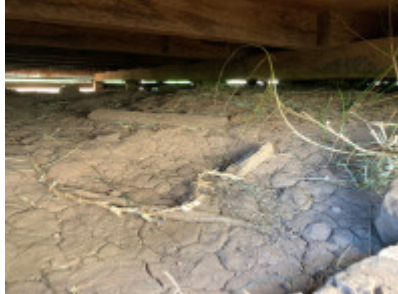
<p>Subfloor Too low for physical access</p>

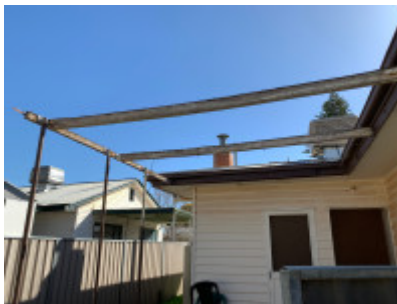
<p>Rear timber pergola frame moisture damage to timbers.</p>

Wood decay fungi are conducive to subterranean termites. You should consult a builder or other building expert to find out what must be carried out to prevent further decay (repairing of drainage, leaks and/or sealing the timber) and repair the damage.

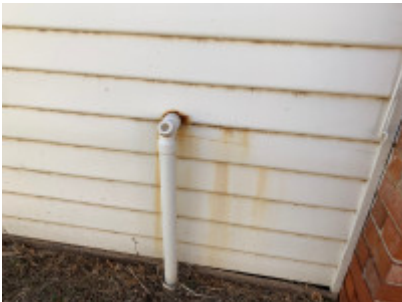
Kitchen drainage
leaking

all front down pipes not connected to storm water drainage. Kitchen sink drainage leaking.

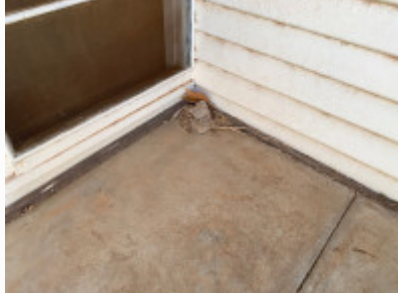
<p>rear patio Concrete patio poured above and against subfloor timbers</p>

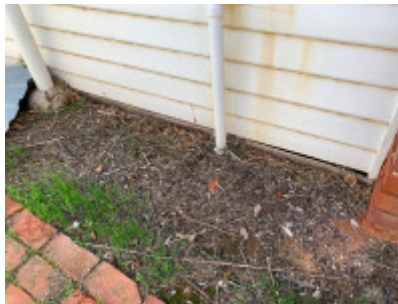
<p>perimeter ground level high against timber wall</p>

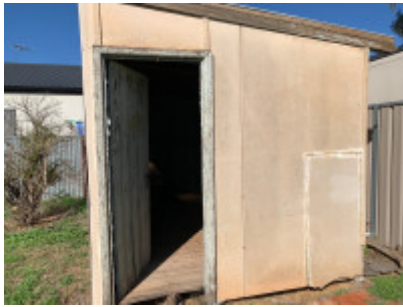
Timber outbuilding
Timber floor

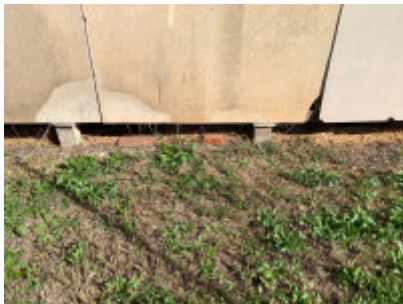
Timber outbuilding
On timber stumps (no access too low)

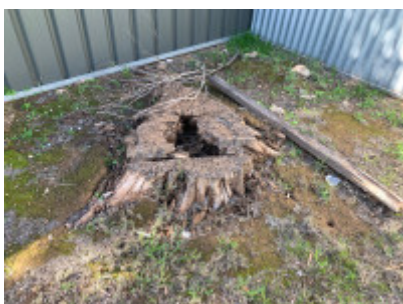
Yard
Tree Stump
